United States Steel Corporation

Resolution Manual For Metal Building Construction

Job Site Imperfections

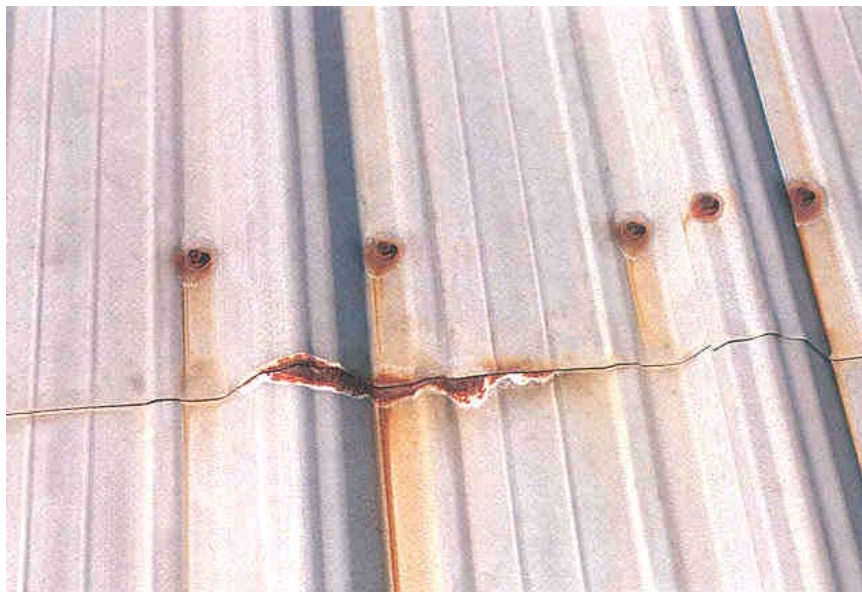
Sealant should be applied at panel end laps to prevent moisture from entering the panel lap joints and causing premature corrosion. Figure 24 ⁵ shows the crevice corrosion caused by poor end lap sealing on a GALVALUME® roof. Figure 25 shows the paint blistering on a prepainted GALVALUME® roof caused by poor end lap sealing.

Figure 24. Crevice corrosion caused by poor end lap sealing on a GALVALUME® roof.

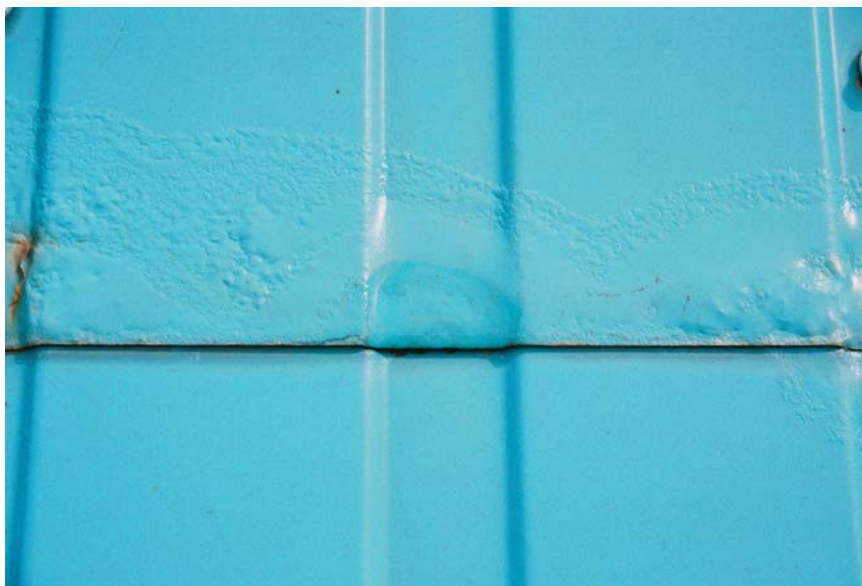
Figure 25. Paint blistering on a prepainted GALVALUME® roof caused by poor end lap sealing.

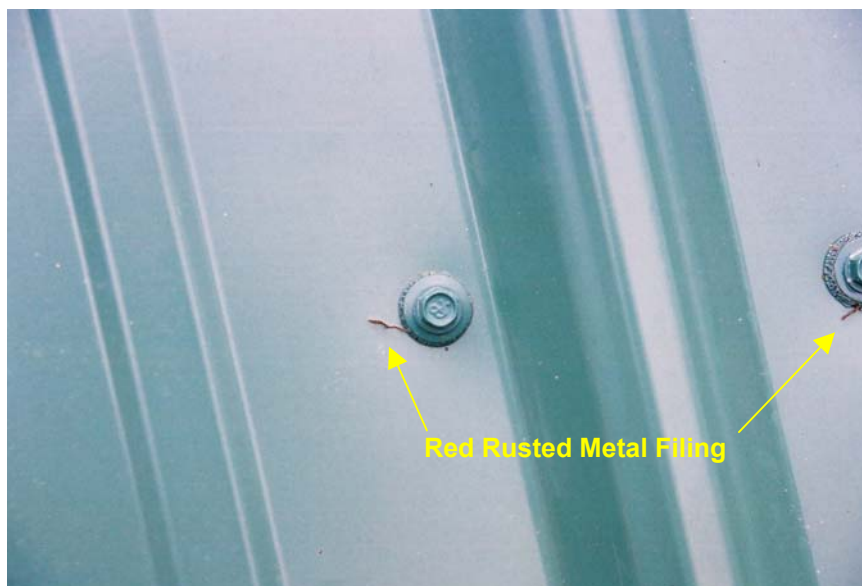
Figure 28. Photograph of red rusted metal filings from the screws on a prepainted GALVALUME® roof panel.

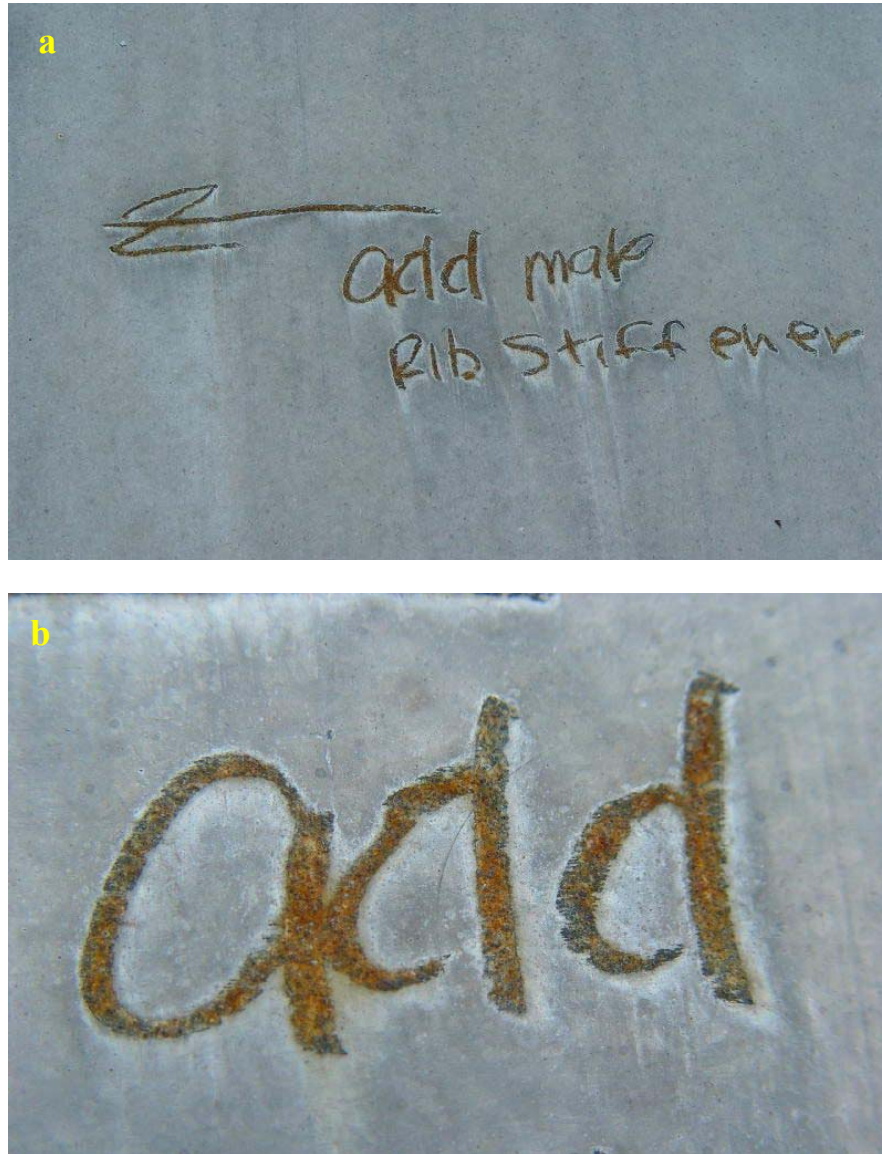
Pencil is made of graphite. When a pencil is used to write on galvanized steel it leaves graphite powder on the surface. Figure 29 is an example of pencil mark corrosion on galvanized steel sheet. Pencil mark corrosion is a form of galvanic corrosion. Because graphite is electrochemically very noble, 3 to 4 volts more noble than the zinc, a strong galvanic cell is created and the zinc on or adjacent to the pencil mark rapidly corrodes. The open circuit potential of graphite is cathodic to all metals and alloys in most aqueous environments. One should never write on galvanized steel with a pencil.

Figure 29. Photographs of pencil mark corrosion on galvanized steel sheet (a), and a magnified view of the mark (b).

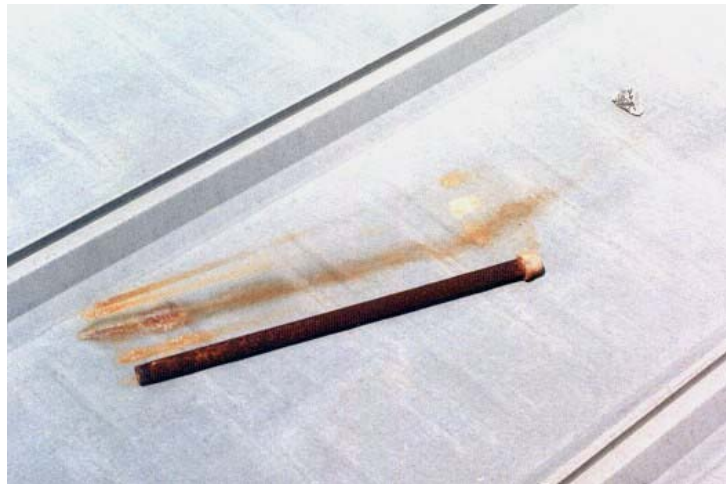
Figure 32. A piece of metal tube left on the roof caused staining and corrosion of the roof panel.
