United States Steel Corporation

Resolution Manual For Metal Building Construction

Job Site Imperfections

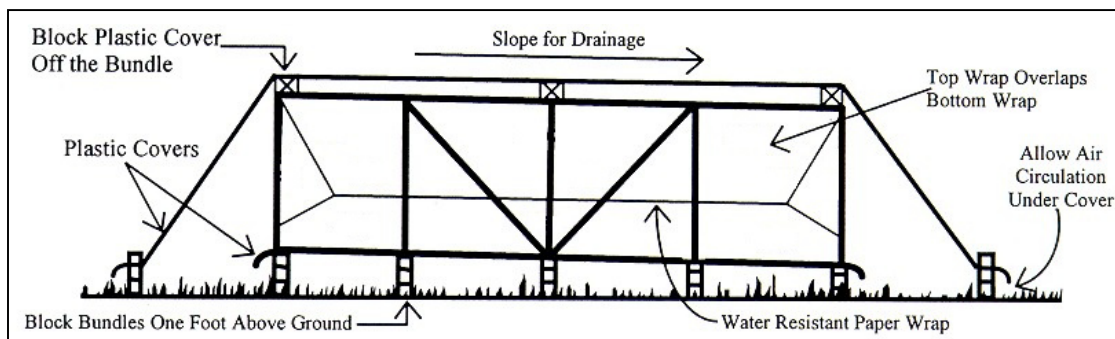
Figure 7. Schematic of proper storage of building panel bundles at job site.

Bundles should be positioned with one end slightly elevated to permit runoff of moisture from the top of the bundle or from between nested panels. Water-resistant paper will not necessarily provide long-term resistance to moisture penetration from puddled water on top of the bundle. A waterproof cover should be placed over the bundles while allowing for air circulation under the cover (see Figure 7). More information can be found in U. S. Steel Technical Bulletins at <http://www.ussconstruction.com> or in the National Coil Coater's Association Technical Bulletins at <http://www.coilcoating.org>.

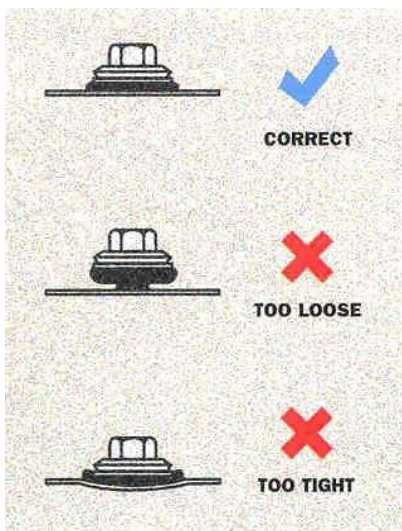
Figure 10. Schematic example of the proper and improper installation of fasteners.

Fasteners should be installed properly to avoid being over-driven, under-driven or driven at an angle. Figure 10³ is a schematic example of the proper and improper installation of fasteners. Properly seated and installed fasteners should be watertight and not allow water to leak or allow water to collect around them. Over-driven fasteners may cause depressions around the fasteners, which can collect water and accelerate corrosion. Therefore, impact-type tools should not be used. Figure 11 is an example of over-driven fasteners. The GALVALUME® material around the fasteners was corroded due to water ponding in the depression. The corroded area around the fastener increased with increasing the depth of the depression. Under-driven fasteners or fasteners that “back out” over time can allow water to leak at fasteners allowing water to saturate insulation causing inside-out corrosion (Figure 12⁴). Driving tools with depth-sensing nose-pieces and suitable speeds can help to avoid these problems.

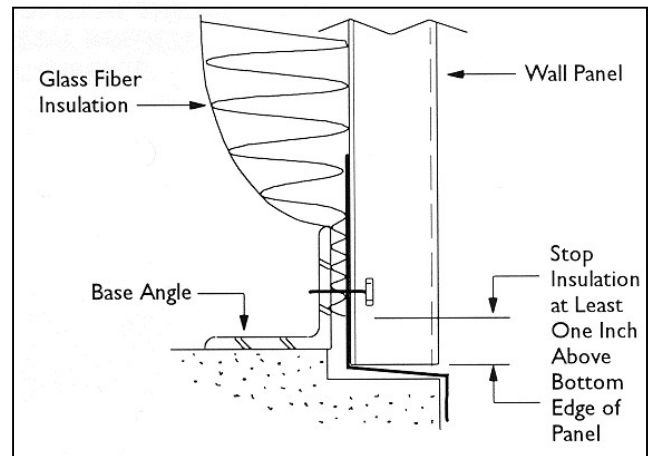
Figure 17. Schematic of properly installed insulation.

Figure 16 is a classic example of “insulation wicking” causing premature failure of the coated panel. The insulation soaked up the available moisture creating an environment that was always wet causing accelerated corrosion. The contractor should be fully aware that insulation and other building materials that can soak up moisture should not be exposed to the exterior of the building. One solution is to install the insulation at least one inch above the bottom edge of the panels and to fold the insulation face around the bottom edge of the fiberglass (see Figure 17).

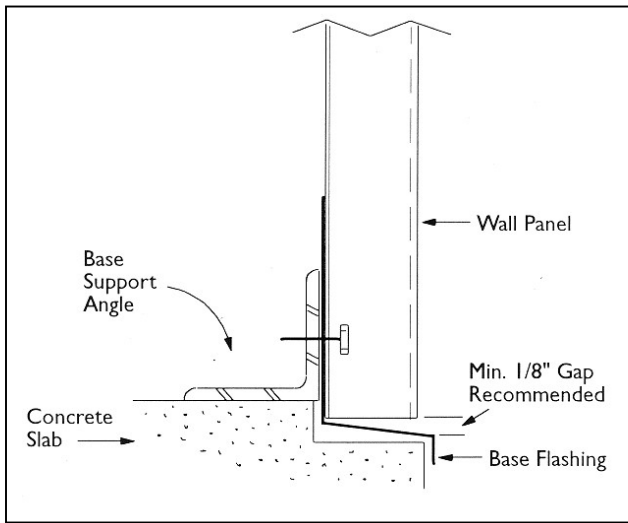
Figure 19. Schematic of proper siding installation.

One of the many factors contributing to long-term performance of a steel roof or siding system is the design and installation of panel flashings. The flashing details can significantly affect both weather tightness and corrosion resistance especially at the siding base. The bottom cut edge of a panel should not be in direct contact with concrete to prevent potential premature corrosion. A steel base trim is recommended at the panel termination to direct the water away from the base of the panel. However, the bottom cut edge should also not be in direct contact with the horizontal leg of the steel flashing to allow the free flow of the water (Figure 19). All flashings should be designed to drain water to the outside of the building and away from the cut edges of the panel. A minimum of 5° slope is desired for promoting drainage of rainwater or condensation away from the panel edge (Figure 20).
