Medallion I and Medallion II Standing Seam Systems

Medallion I and Medallion II

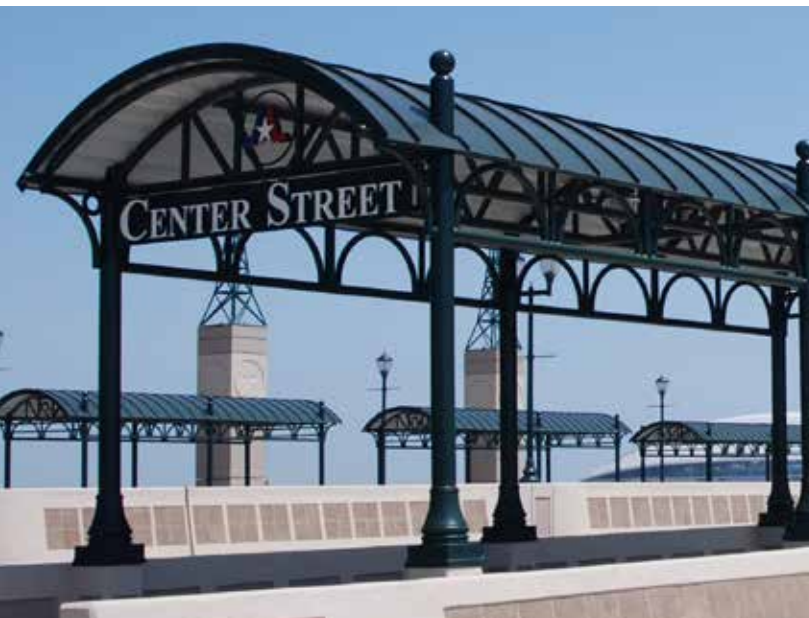
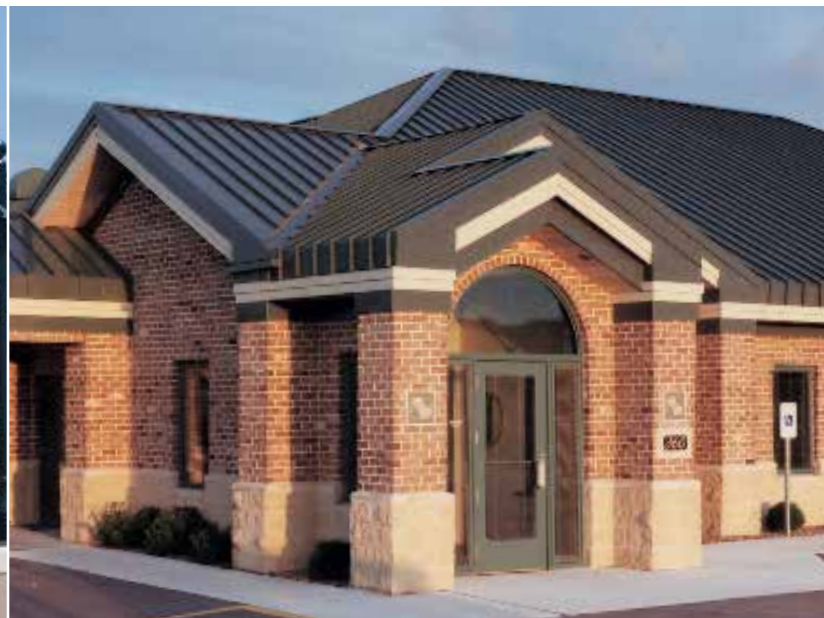
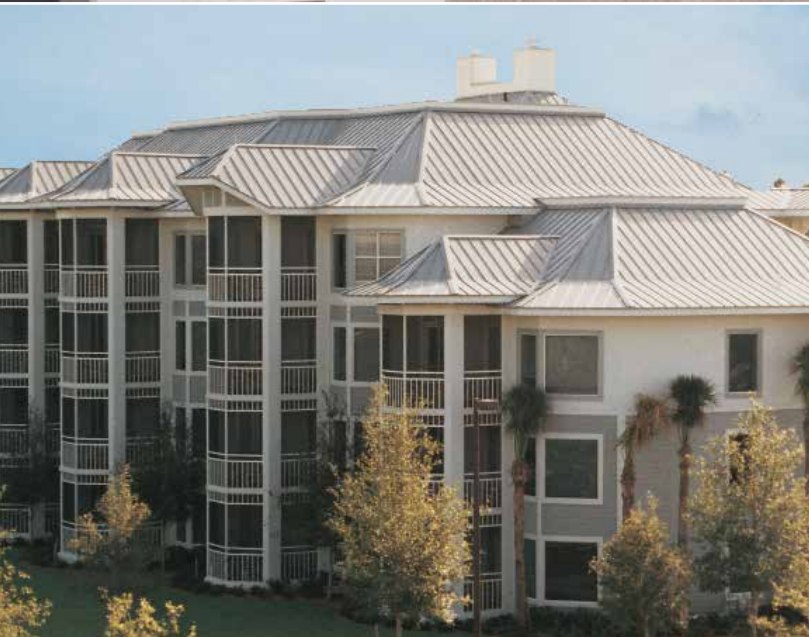
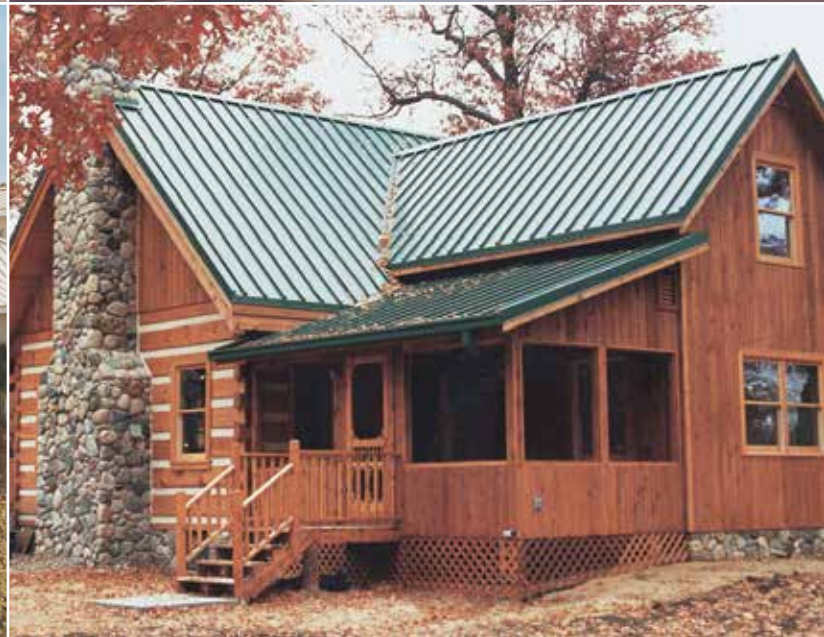
*Cover width is pan width plus 1"

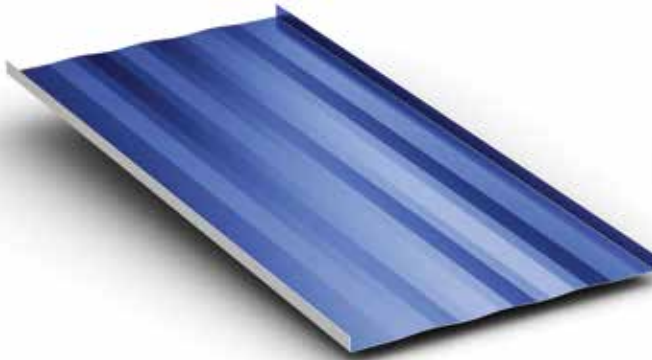
Medallion I Batten

Medallion I is an architectural standing seam system featuring a narrow batten cap applied over roofing panels and concealed clips. Medallion I is installed over solid deck and can also be curved to meet radius panel specifications.

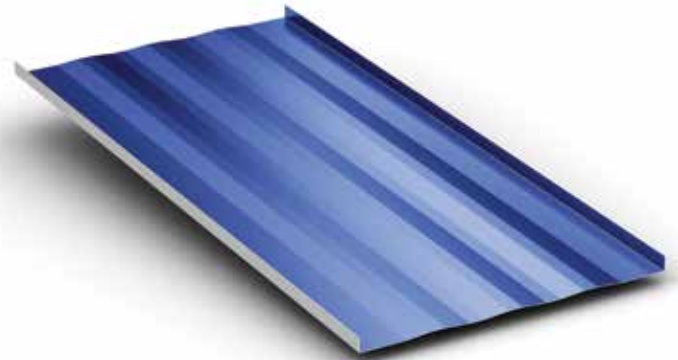
Medallion II Batten

Medallion II is an architectural standing seam system that features a 1 1/2" wide batten cap applied over roofing panels and concealed clips. Medallion II is installed over solid deck.
